# **Facts and Lessons of the Fukushima Nuclear Accident and Safety Improvement -The Operator Viewpoints-**

September 19, 2012

DOE Nuclear Safety Workshop, @Bethesda, Maryland

Tokyo Electric Power Company

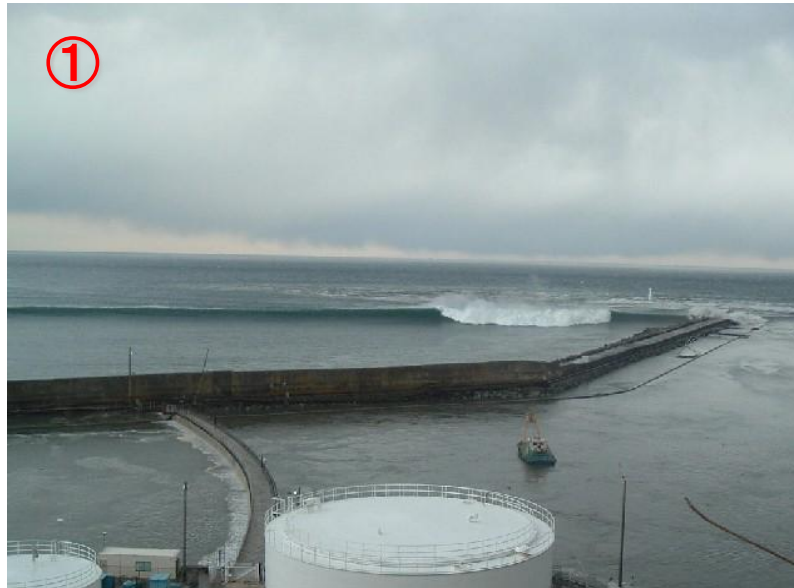
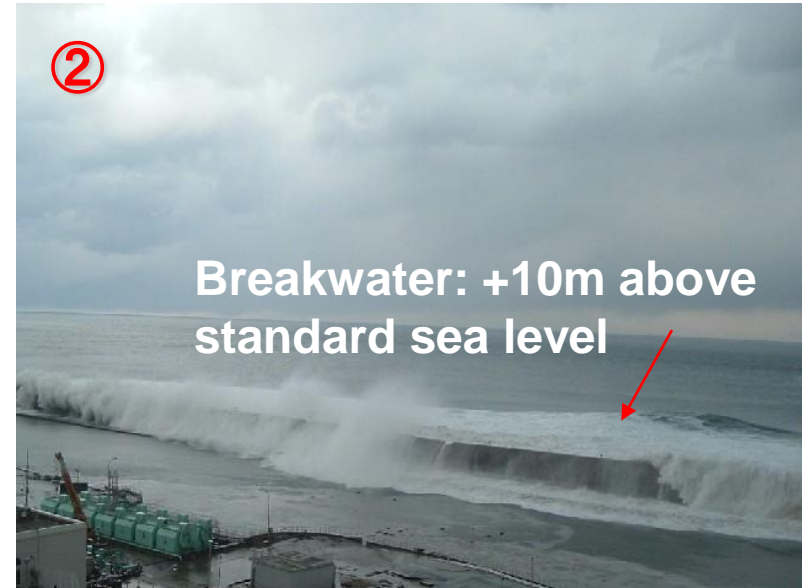
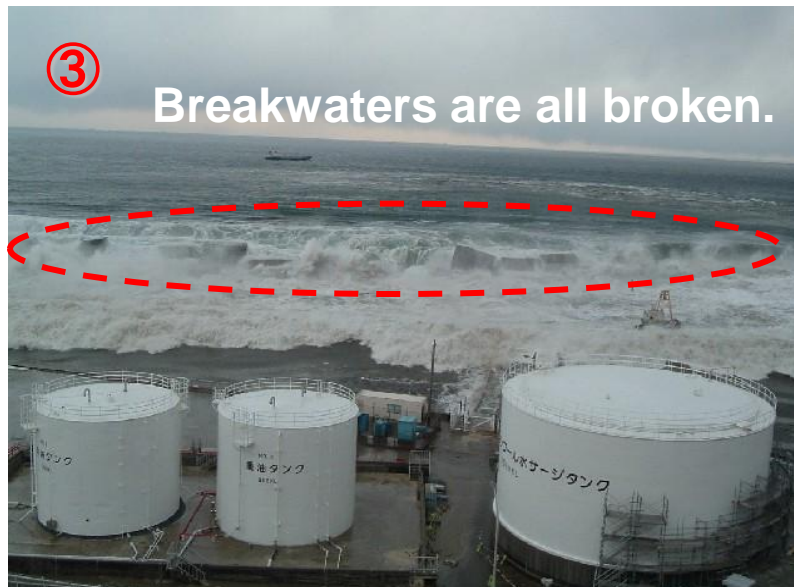
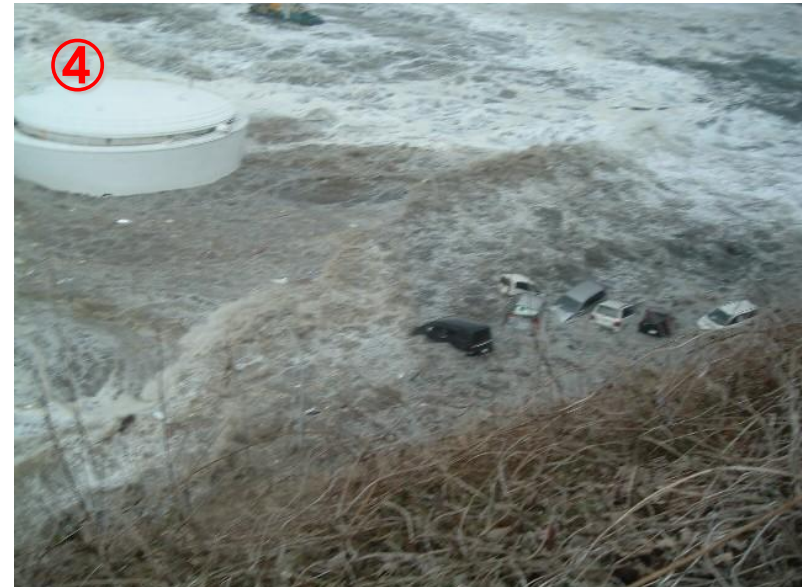
< pictured from upland nearby Unit 5 >

# Tsunami observed at Fukushima Daiichi (1F)

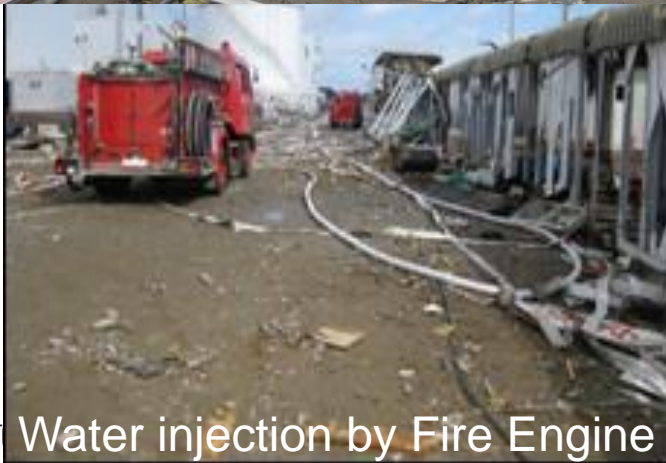
Water injection by Fire Engine

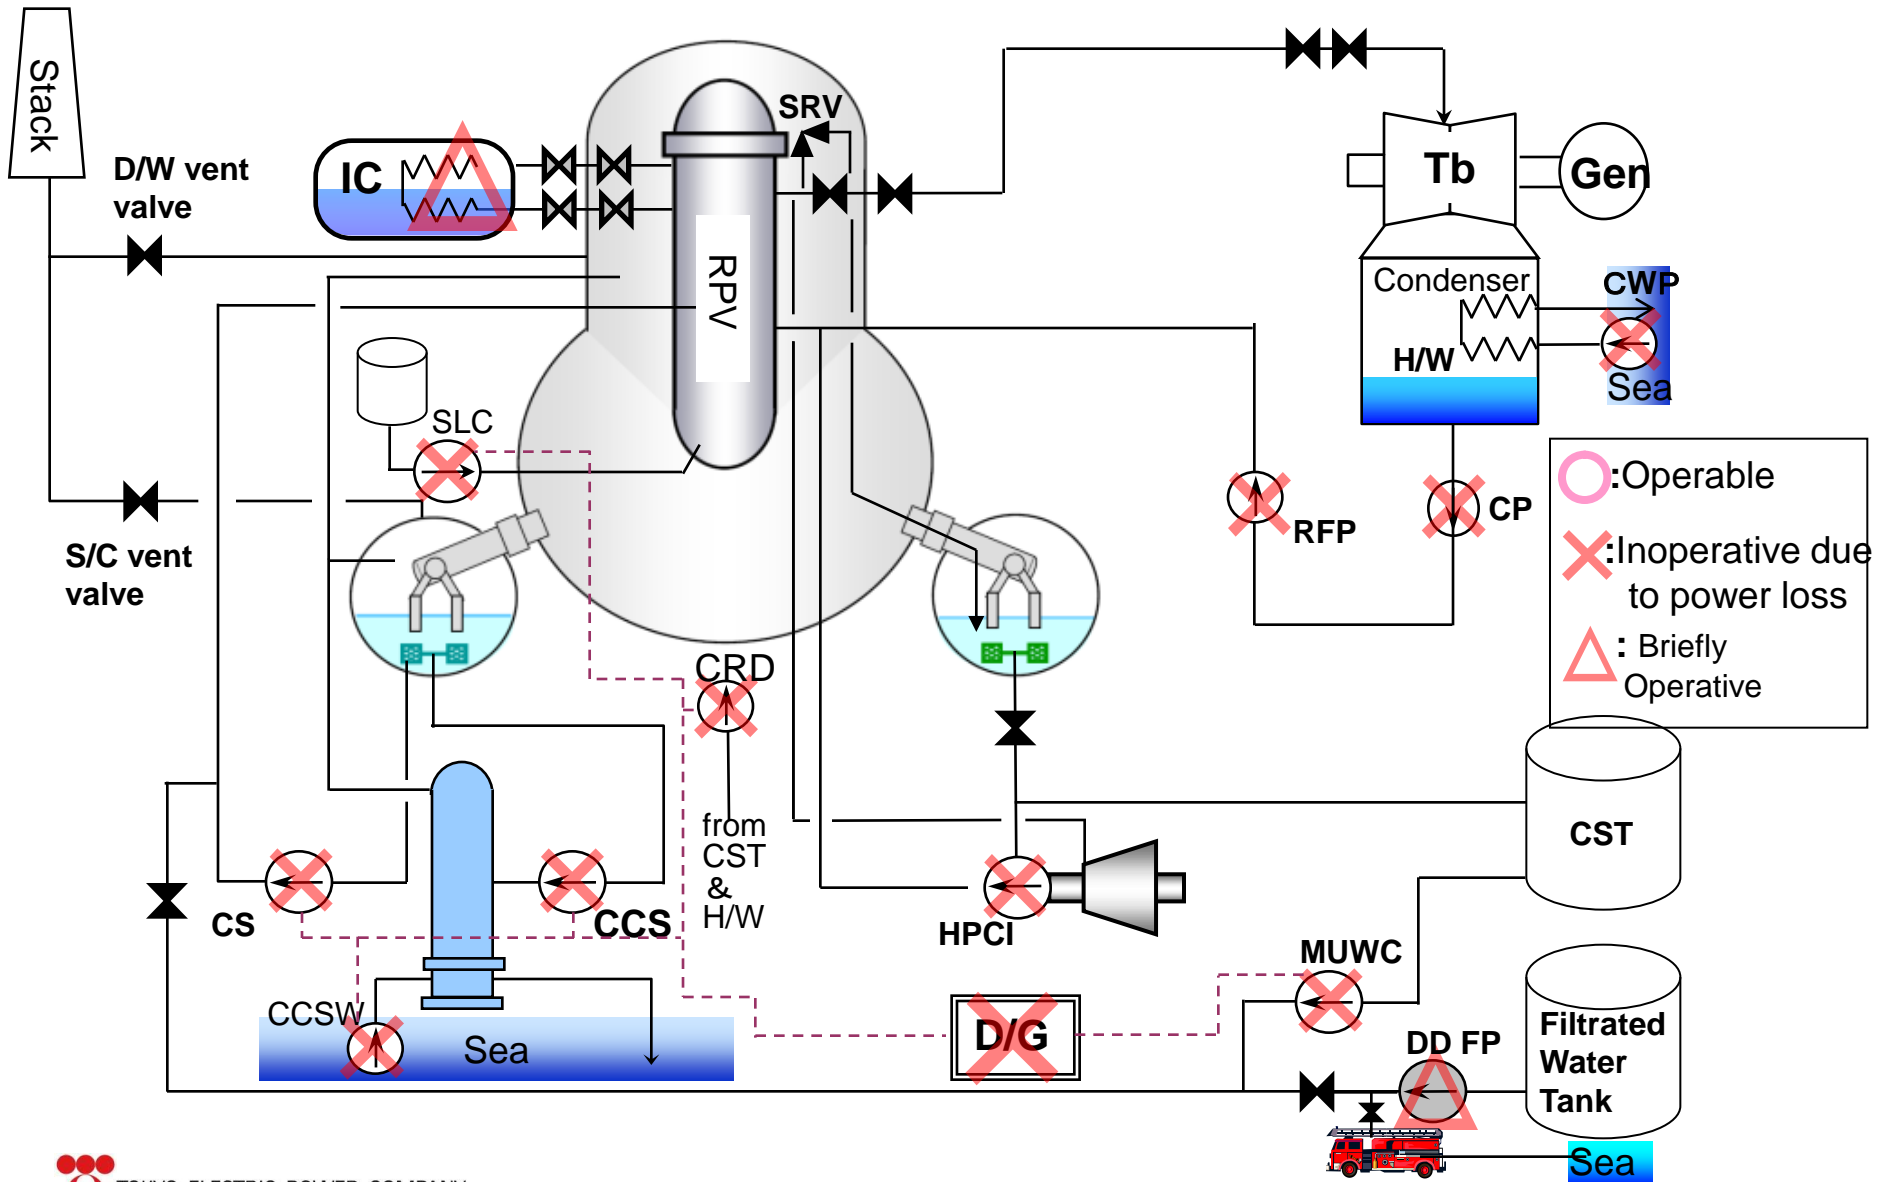
# 1F Unit 1 Schematic System Diagram (After Tsunami)

It is considered that core damage had progressed in a short period of time after the tsunami. Hence, the status of the IC, which is used to cool the reactor in the initial stages after shutdown, might have affected the event progression.

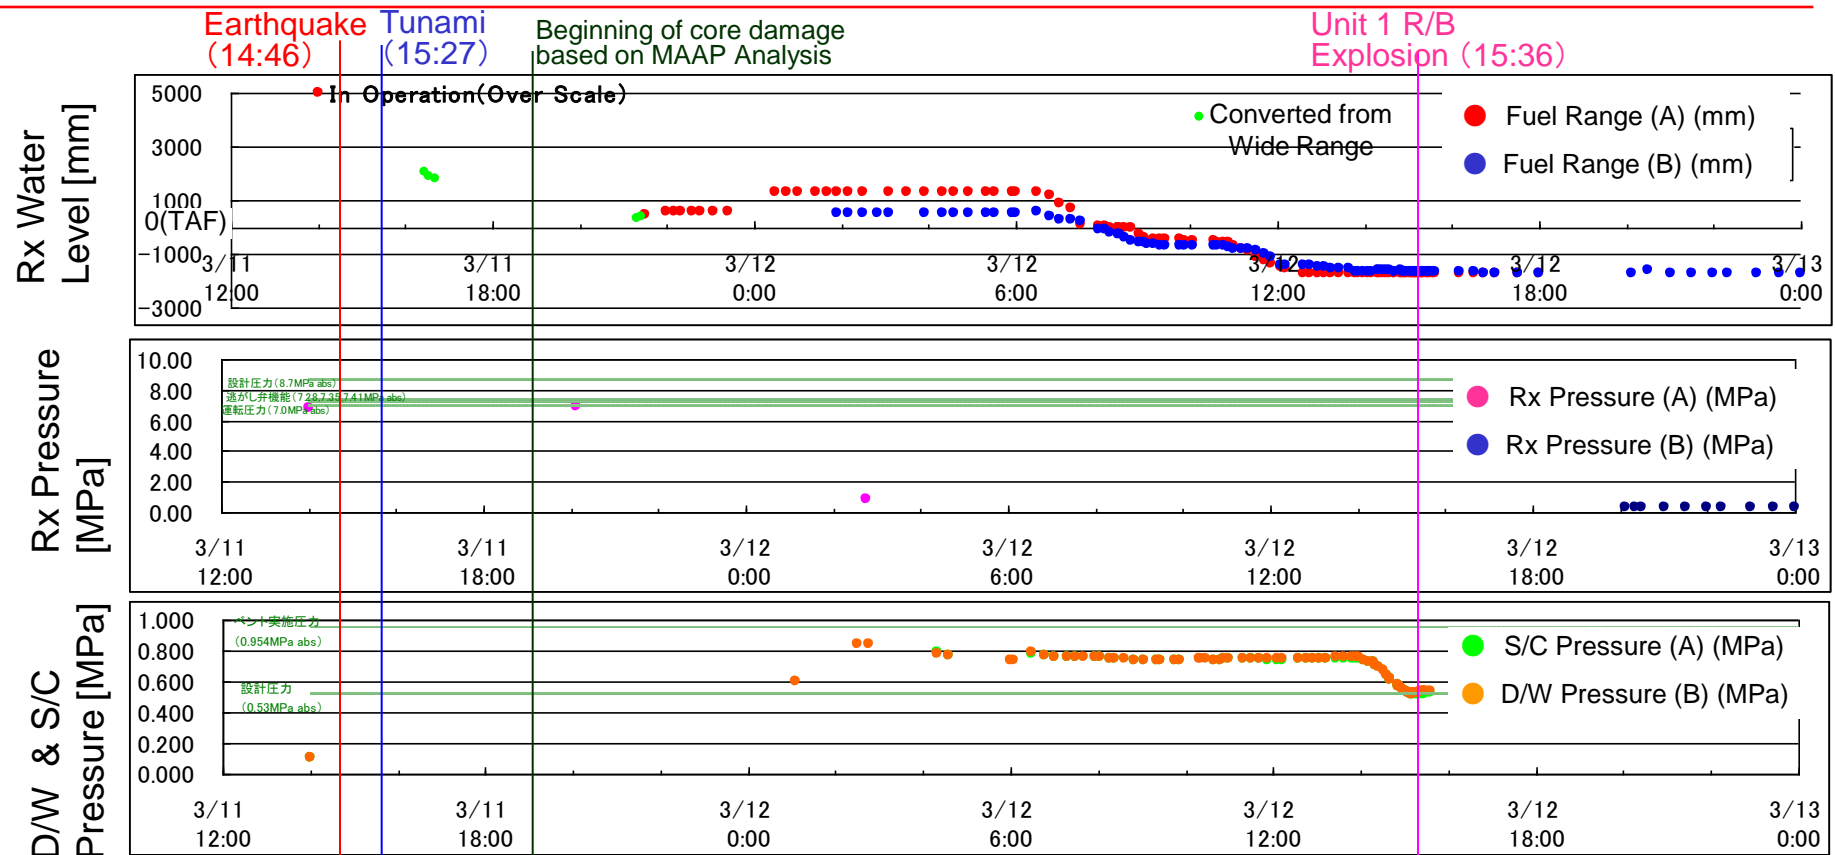
# 1F Unit 1 Plant Parameter and Operation

IC	(14:52) (18:18) (21:30)	Operation Unclear
HPCI	No Operation	
SRV	No Operation	
FP/Fire Engine	(5:46) Fresh Water [80t] (14:53) (19:04) Sea Water	
PCV Vent	Order for Vent Preparation (0:06) ▼	Order for Vent ▼ (8:03) (14:30) D/W Pr decrease confirmed

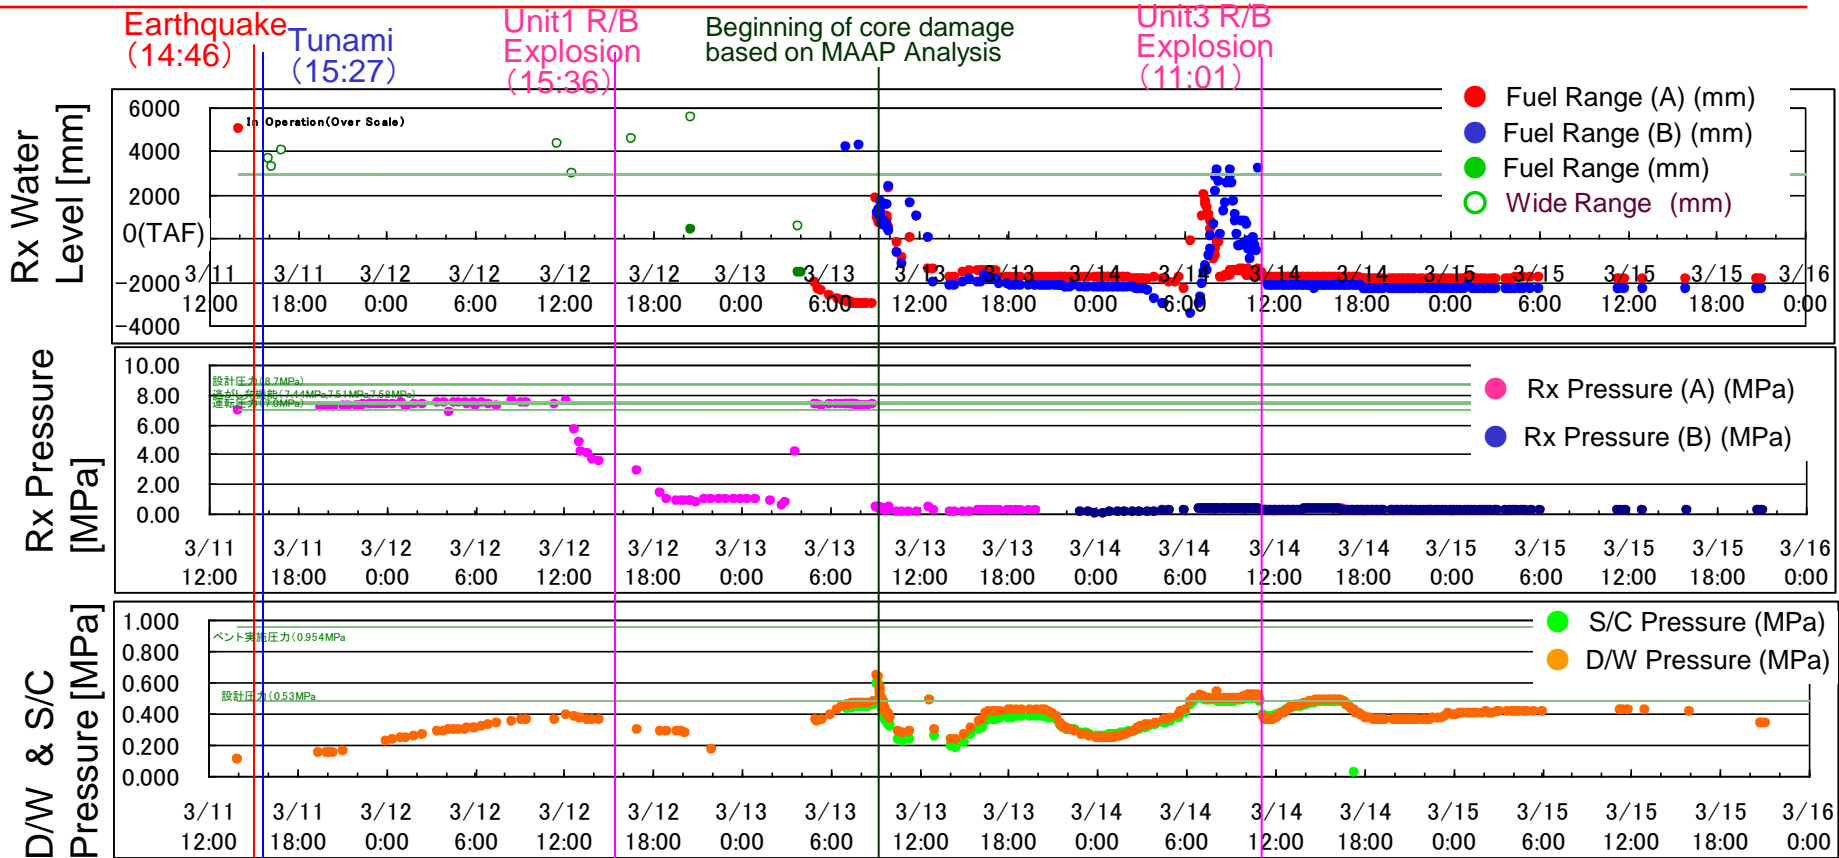
# 1F Unit 3 Plant Parameter and Operation

RCIC	(16:03)	(11:36) Trip
HPCI	Automatic Start (12:35)	(2:42) Trip
SRV		(~9:08) Depressurization
FP/Fire Engine	Order for Preparation ▼ (17:12)	(9:25) Fresh Water (13:12) Sea Water (16:30) Sea Water
PCV	Order for Vent Preparation ▼ (17:30)	(8:40) Vent Line Configuration Completed

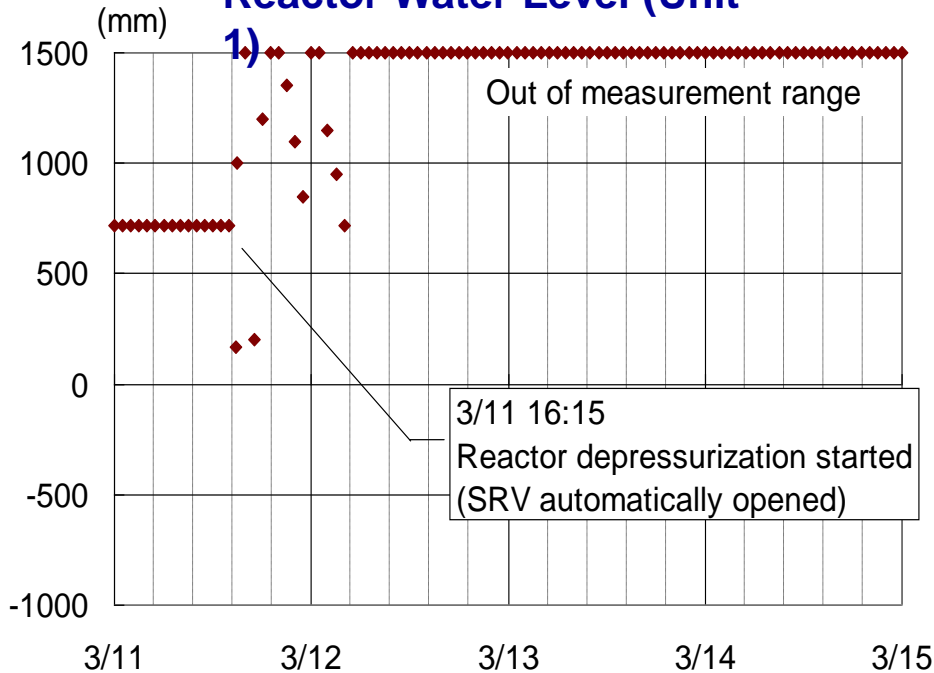
## Reactor Water Level (Unit 1)

Securing uninterrupted water injection throughout the depressurization process with RCIC at high pressure condition and MUWC at low pressure condition was a critical factor for successful reactor cooling.

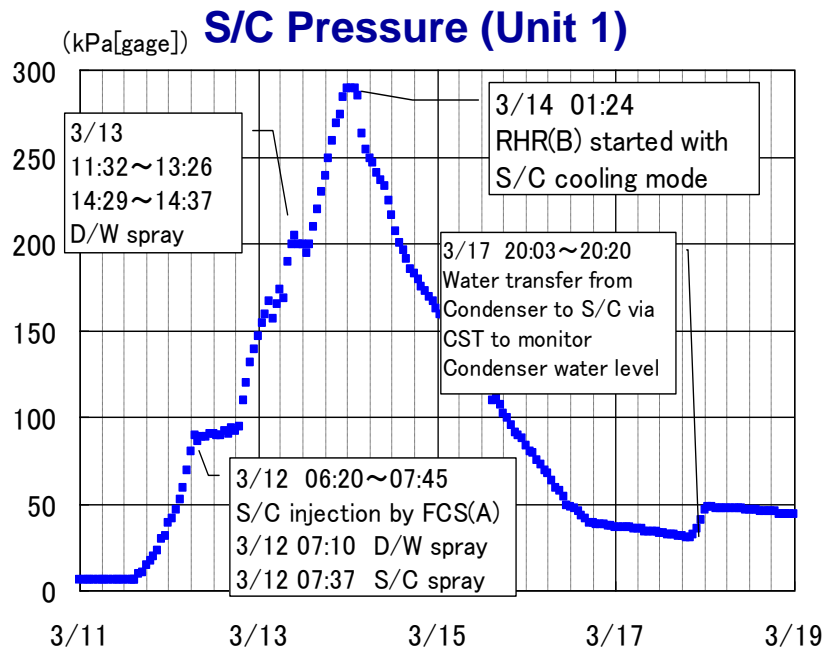
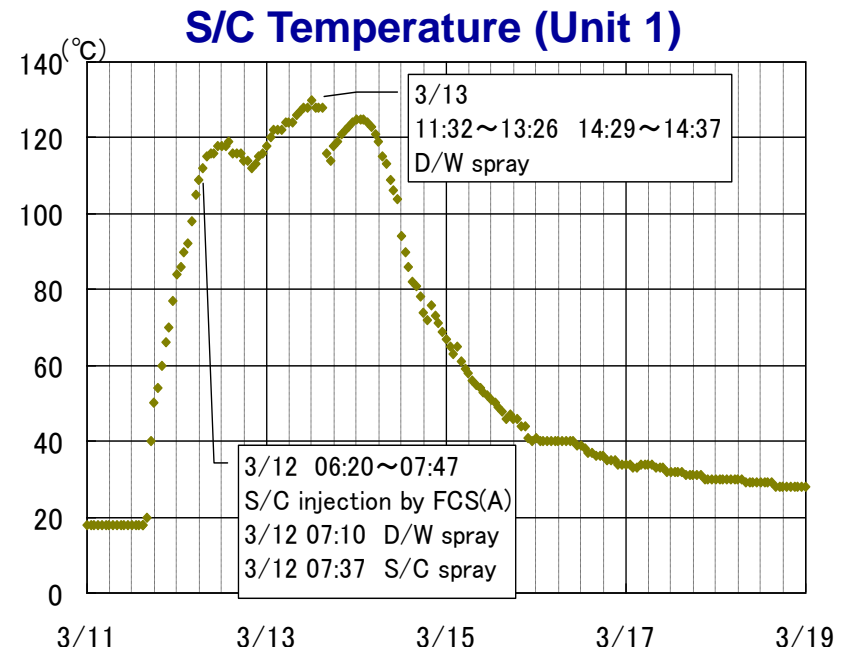
- ~~S/C water temperature reached 100°C (212F).~~  
→ It eventually increased up to about 130°C (266F).
- Water injected to S/C through Hydrogen Recombiner cooler discharge line in order to mitigate temperature and pressure increases.
- Alternative injection to reactor using MUWC switched to D/W spray, then S/C spray.
- S/C temperature decreased after restoration of RHR.

**EOP includes an alternative water injection measures employing MUWC .**  
**Flexible approach to cool S/C using Hydrogen Recombiner worked well.**

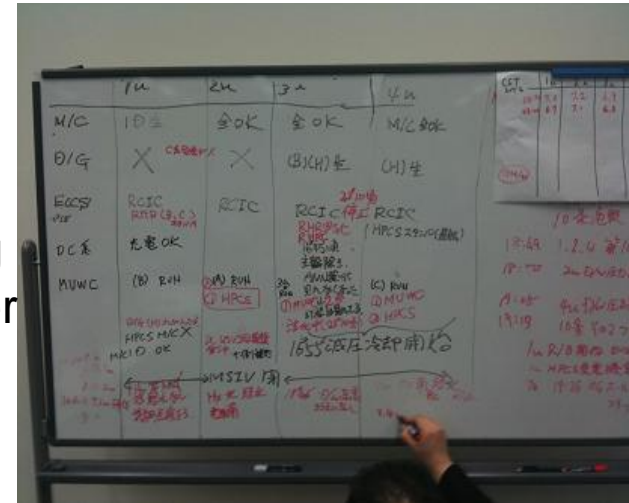
**In order to establish a well-prioritized restoration strategy, degree of damage and possibility of short-term restoration must be understood through walkdown.**

- Challenges in conducting field walkdown
  - Under continuous tsunami alerts, walkdown must be done in the field where a lot of debris, openings and flooding areas existed in the dark.
  - Preparation for emergency evacuation in case of further tsunami and other safety measures for personnel going out to the field.
  - Successful access to the field was 6 hours after the tsunami flooding.
- Field walkdown after the tsunami
  - Plant equipment status checked / component functionality verified.
  - Results were summarized and shared at TSC.
  - TSC set priorities on recovery of RHR (B) cooling systems by replacing motors and supplying power from survived electrical buses and mobile power vehicles through temporary cable.

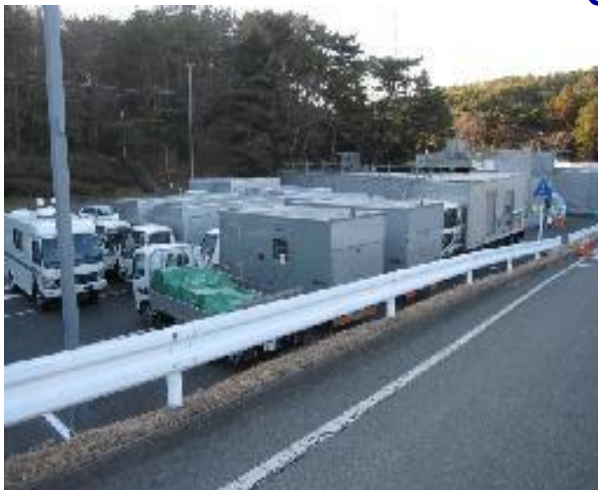
### Mobile Power Vehicles

- Emergency procurement of motors, cable, mobile power vehicles, fuel oil and mobile transformers with close cooperation between site TSC and corporate ERC.
- Rated output of some motors were not the same as that of the original motors.  
→TSC determined to install them based on the evaluation of actual load conditions.

- Motors were transported from Toshiba by a chopper of SDF and from Kashiwazaki Kariwa NPP by trucks.
- Securing redundant communication measures were critically important when major highway was damaged and public cell phone services were disrupted.

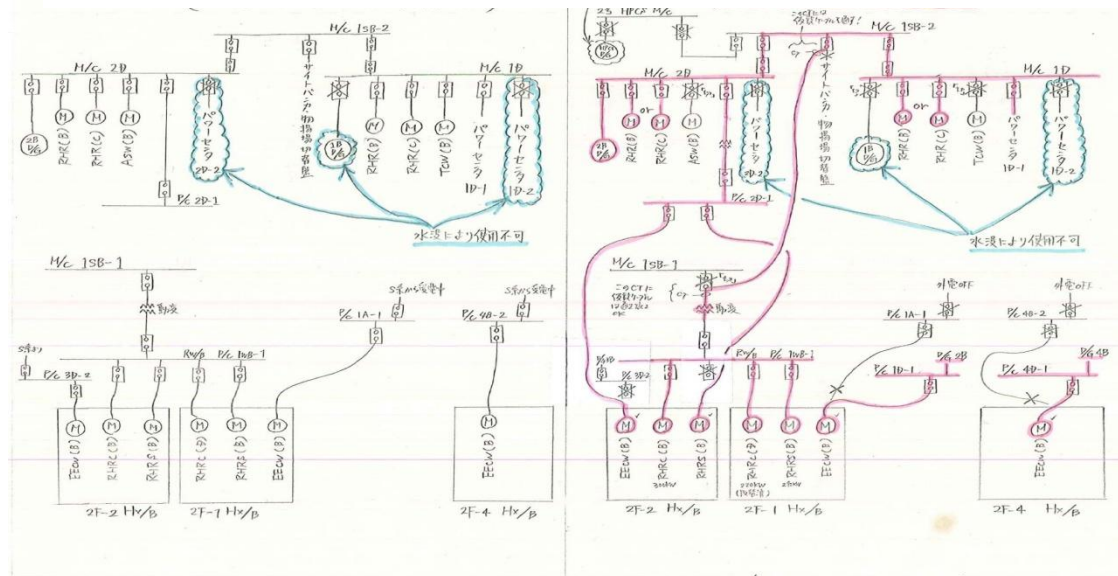
Drawing made at TSC for temporary cable laying

- Pumps of RHR cooling systems (RHRC, RHRS, EECW) were inspected.
- Motors were replaced for pumps in RHRC and EECW.
- In order to restore the inundated electrical buses, temporary cable and high voltage mobile power vehicles were deployed.
- Temporary cable was laid from survived power cubicles in Rad-Waste Building and Unit 3 Heat Exchanger Building.

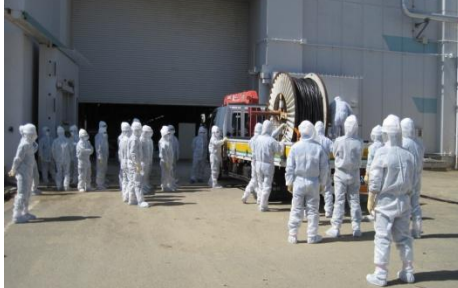
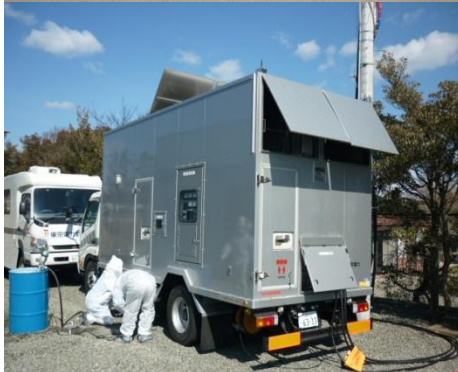
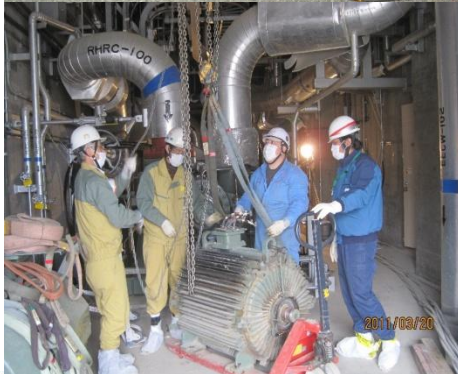
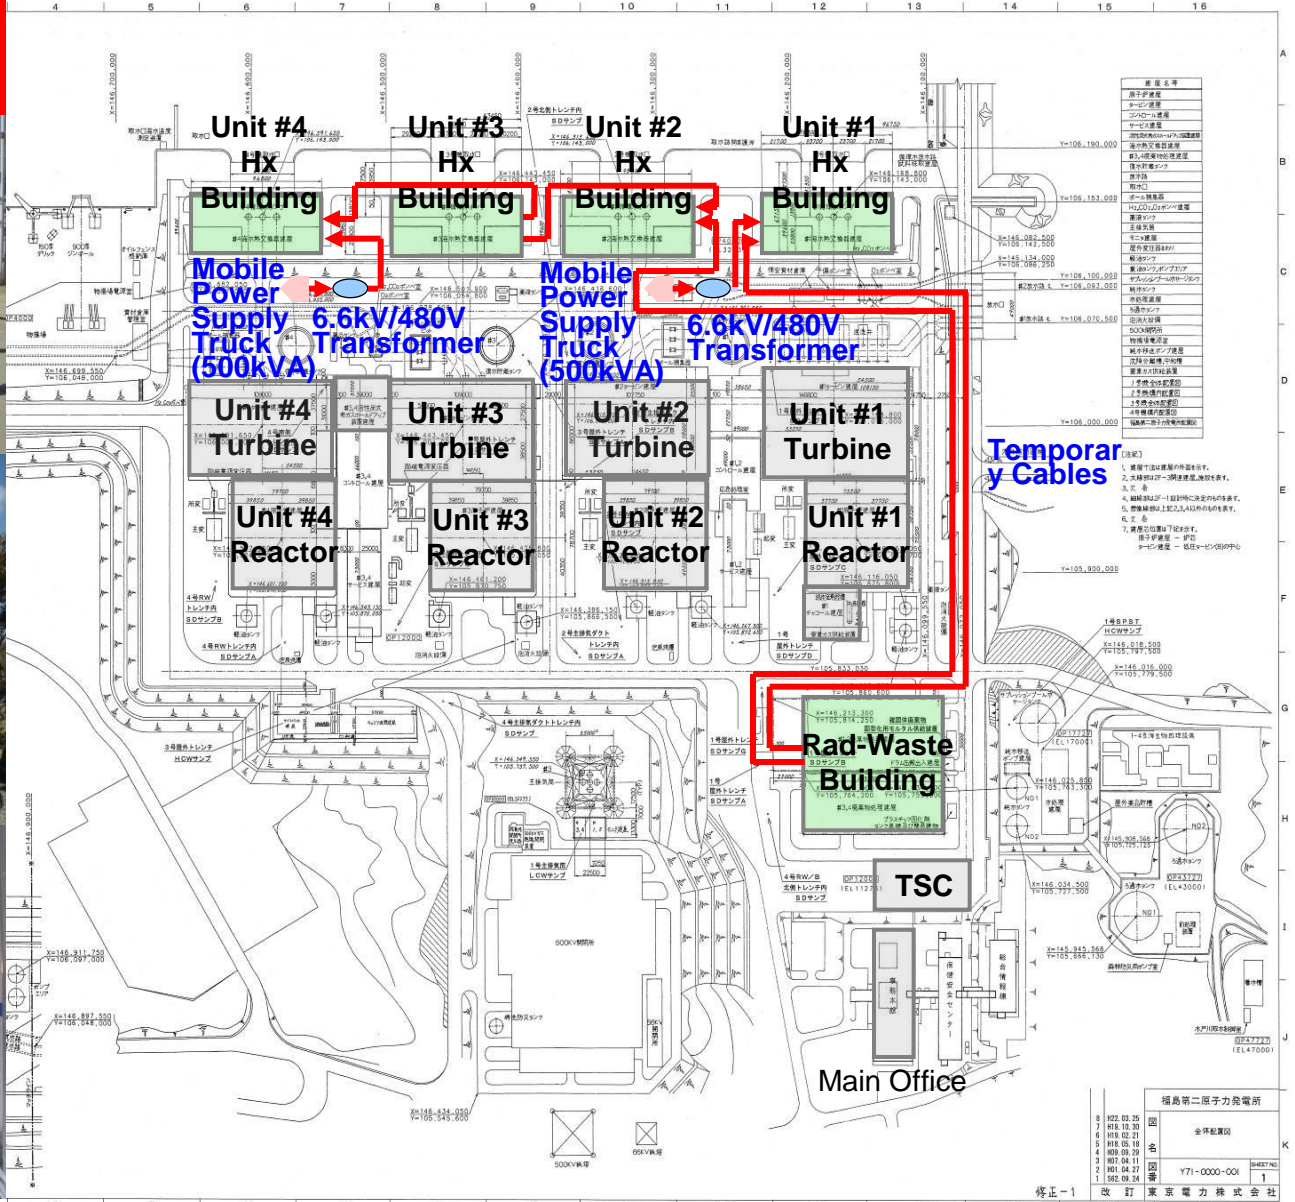
# Temporary Power Supply and Motor Replacement at 2F

About 9 km of temporary cables were laid and motors were replaced.
